Voyagaki, E., Kloukinas, P., Novelli, V., De Risi, R., Kafodya, I., Ngoma, I., Goda, K., & Macdonald, J. H. G. (2020). *Masonry panel testing in Malawi*. Paper presented at 17th World Conference on Earthquake Engineering, Sendai, Japan.

## MASONRY PANEL TESTING IN MALAWI

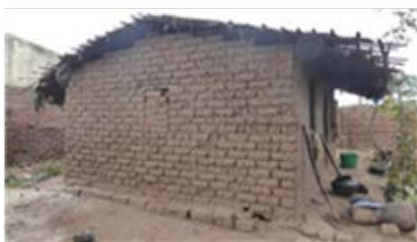
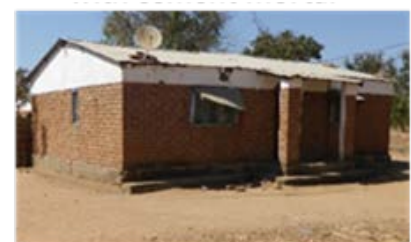
(a) unfired bricks / mud mortar

(b) fired bricks / mud mortar

(c) fired bricks / cement mortar

Fig. 2 – Typical houses in rural and urban areas of Malawi made of unreinforced bricks and mortar. [7]

Fig. 2 shows typical houses in Malawi that are, almost exclusively, one-storey buildings made of locally moulded, sun-dried or fired clay bricks and mud or low-strength cement mortar. Walls are often single-skin, against the local guidelines. Double-skin walls are built in the case of higher-income households; however, they are not always adequately constructed. Roofs are typically pitched, constructed by wooden beams and covered using iron corrugated sheets, or thatched (Fig. 2(b)). Quality of materials is low; compressive strengths of bricks vary between 1 and 10 MPa (typically lower than 5 MPa), even within the same batch. The mortar used to bond the bricks varies from plain mud to cement-sand mixtures. The latter typically have a cement-to-sand ratio significantly lower than the either 1:4, suggested for structural masonry (or 1:3 for foundations and special applications) according to MS791-1 [17] or the minimum ratio of 1:6 recommended in the Safer House Construction Guidelines [8]. In local construction practice, the ratio typically depends on the income level of the household and it is generally lower than 1:6 (often 1:8 or even lower) [9].

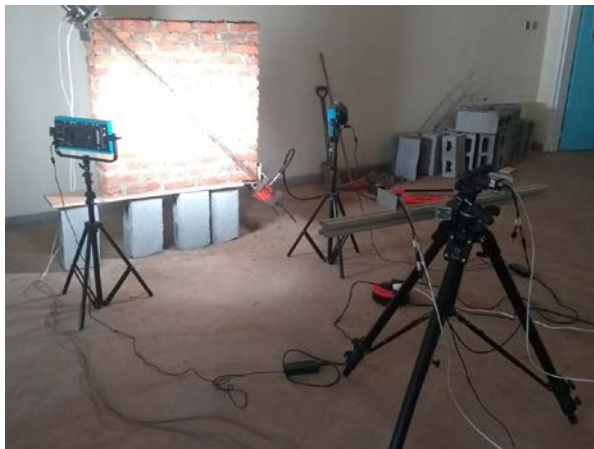
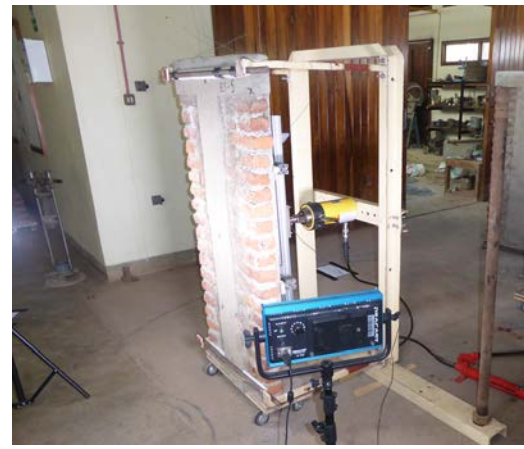
Fig. 6 – The (a) in-plane and (b) out-of-plane testing apparatus and Imetrum Vision System.

The laboratory testing equipment (Fig. 6) consisted of a combination of (1) conventional testing devices with a number of portable testing rigs mountable on the specimens directly and on the strong floor, and (2) a high-precision video tracking system to measure displacements (Imetrum Video Gauge, [25]), with synchronised analogue load cell signals connected to it.

The diagonal compression test was performed according to the in-situ variant of the test with the wall panel upright [26]. Test measurements were: (i) analogue, taken through two synchronised load cells (Fig. 6) attached to the loading shoe in the upper left corner of the specimens; and (ii) digital, monitored by the vision system, in the case of the specific test as strain gauges along the two diagonals of the specimen. In interpreting the above measurements into shear strength, RILEM standards were chosen [26, 27] shown in Fig. 7.

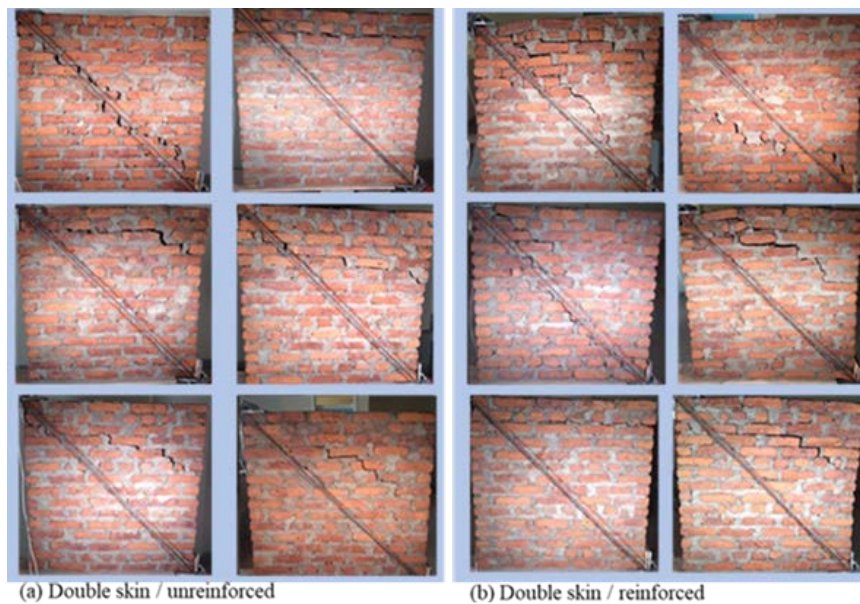
Fig. 11 – Failure mechanisms for in-plane tests on different types of panels: (a) unreinforced and (b) reinforced double-skin walls.

Results from the in-plane shear tests are shown in Fig. 10(a) in the form of peak measured load  $P_u$ . Two types of panels are shown here for comparison: (1) unreinforced double-skin walls and (2) double-skin walls of the same geometry and material, reinforced using horizontal layers of brick force wire. The results indicate that both panel types have almost identical average shear strengths (average peak measured loads in both types of tests were 13kN.) with reinforced panels exhibiting, naturally, a smaller scatter. The failure mechanisms, however, are different as shown in Figs. 10(b) and 11: failure mode in unreinforced panels is brittle, along the mortar interfaces. On the other hand, reinforced panels exhibit a more uniform distribution of cracks – concentrated mostly along the diagonal.
